Manhole Inspection Summary

Manhole # S35C__060MH

Insp Date: **8/10/09 7:41 PM**

Location Address: **112 N Calvert St**

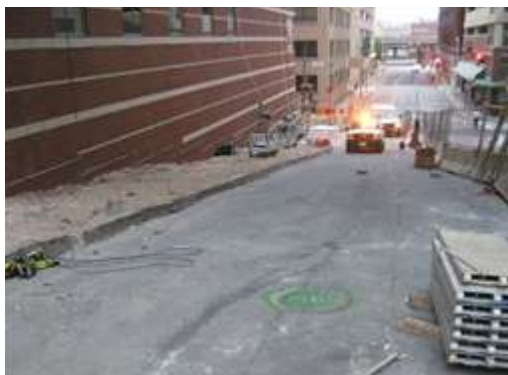
Location View

112 N. Calvert St

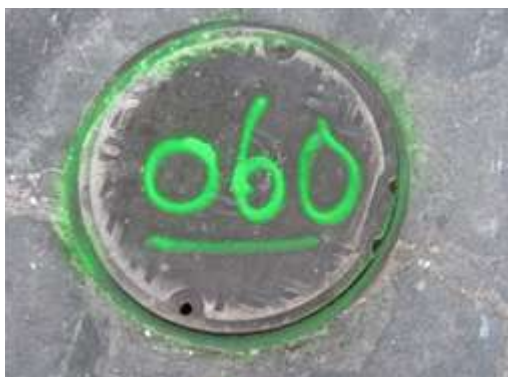
Miscellaneous

Condition: **Worn**

worn mh cover

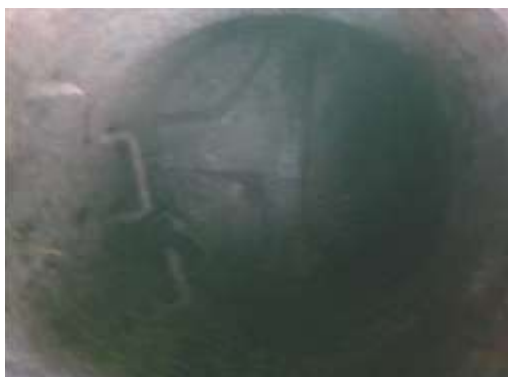
Defect 1

Count: **5** Missing: **2** ☒ **Corroded**

corroded/missing steps

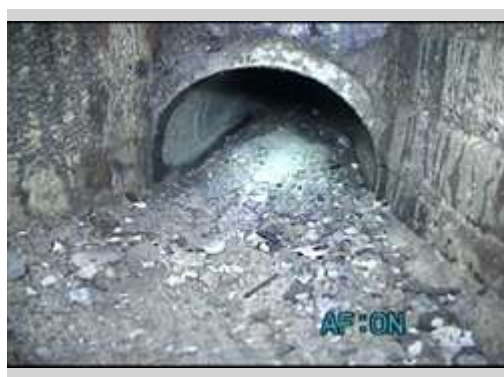
Defect 2

Condition: ☐ Sound ☐ Cracked ☐ Root Intrusion ☐ Deteriorated ☐ Leaks ☒ **Debris**

debris in channel

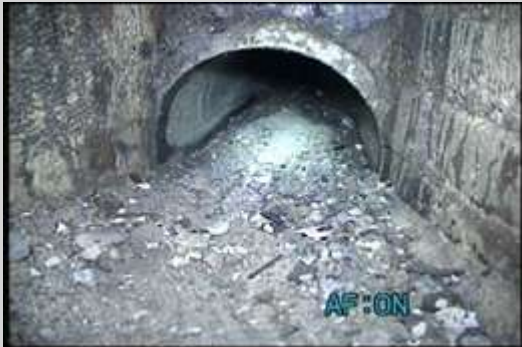
12 O'Clock Outflow

debris in channel

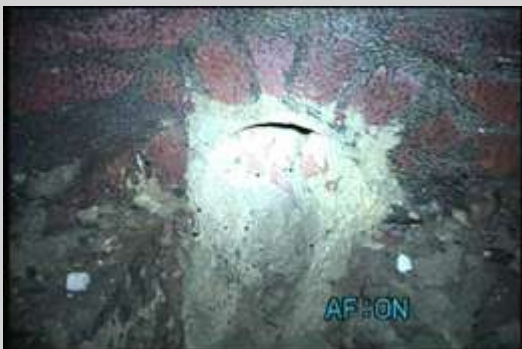
6 O'Clock Inflow

I6...abandoned

Connects To: **Stub connection / abandoned**

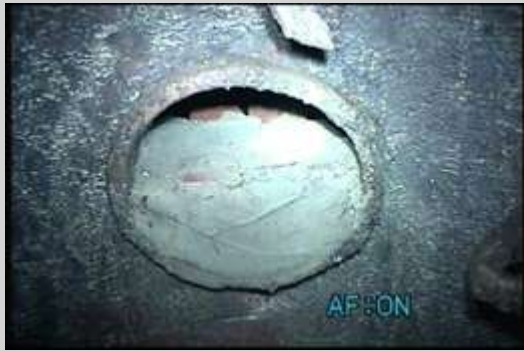
7 O'Clock Inflow

I7 abandoned

Connects To: **Stub connection / abandoned**

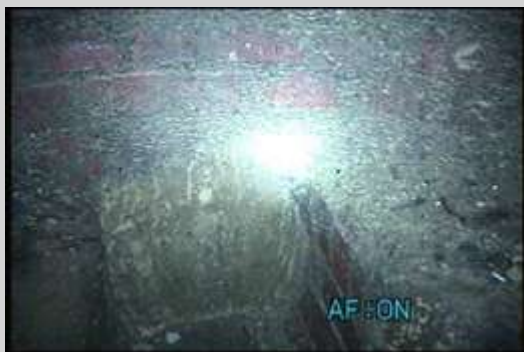
9 O'Clock Inflow

I9 abandoned

Connects To: **Stub connection / abandoned**
